GEOLOGICAL ENGINEERING REPORT, ADDENDUM TO GEOLOGICAL ENGINEERING REPORT, AND GUIDE PILE MEMORANDUM

Subject: Addendum to Geotechnical Engineering Report for the Proposed
Renovations to Dana Point Harbor, City of Dana Point, California

Subject: Preliminary Recommendations for Guide Piles, Dana Point Harbor Renovation,
Dana Point, California

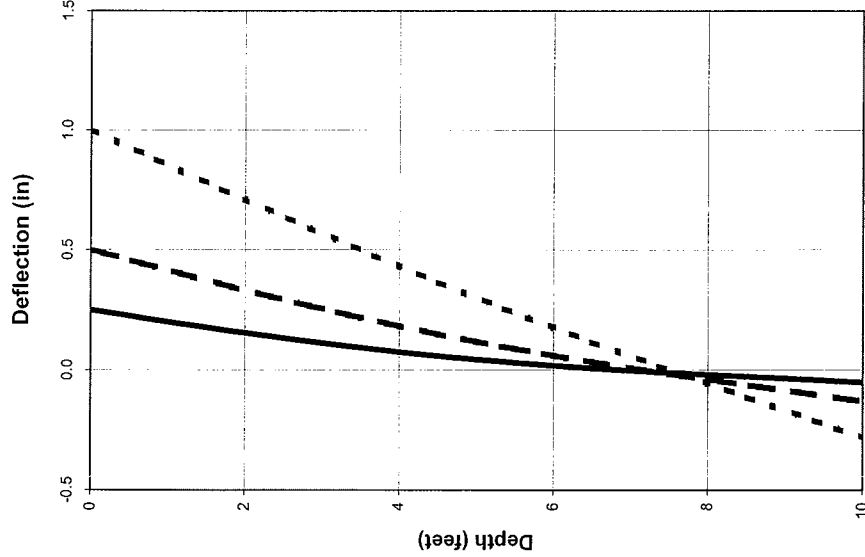
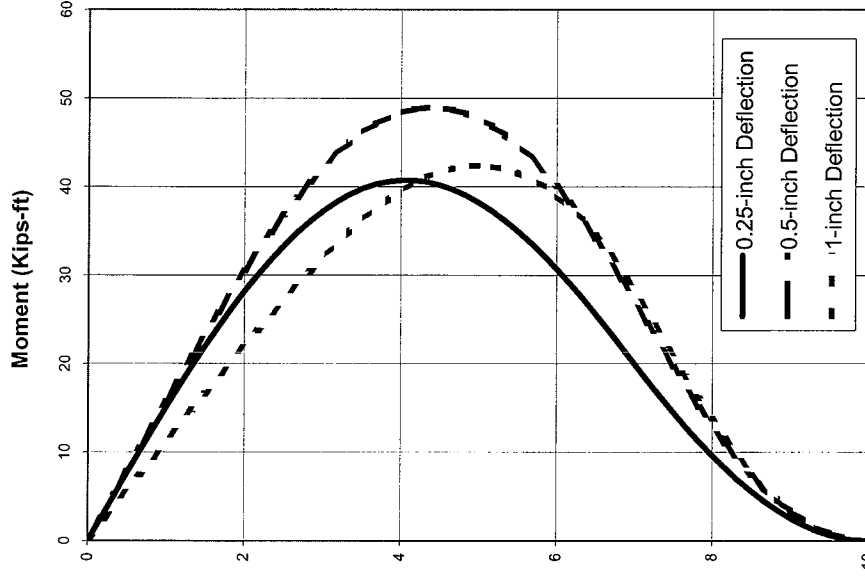
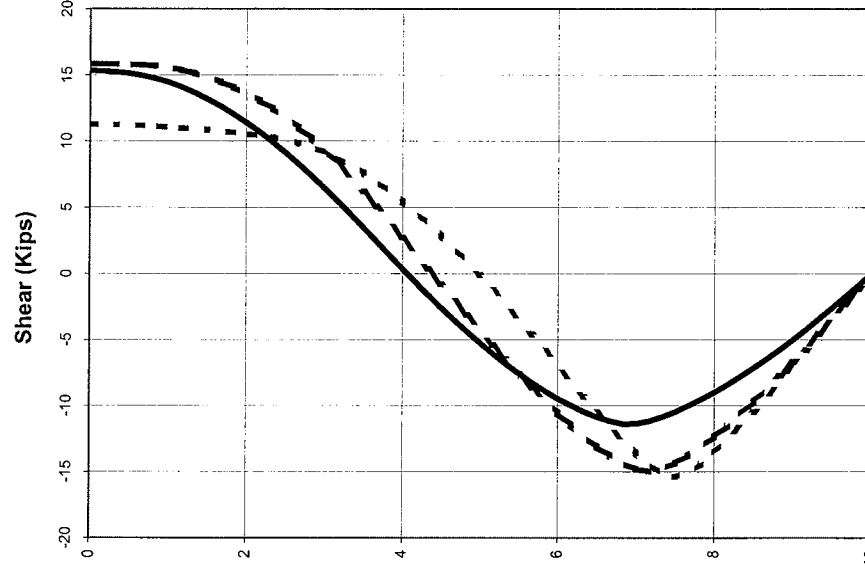
Figure 1a

SECTION A-A' (Boring B-1)

NOTE: Depth is depth of embedment below harbor bottom (k500pci)

LATERAL LOAD CAPACITIES: 14-INCH SQUARE CONCRETE PILE
 10-FOOT EMBEDMENT INTO BEDROCK
 PRELIMINARY SEAWALL EVALUATION
 DANA POINT HARBOR

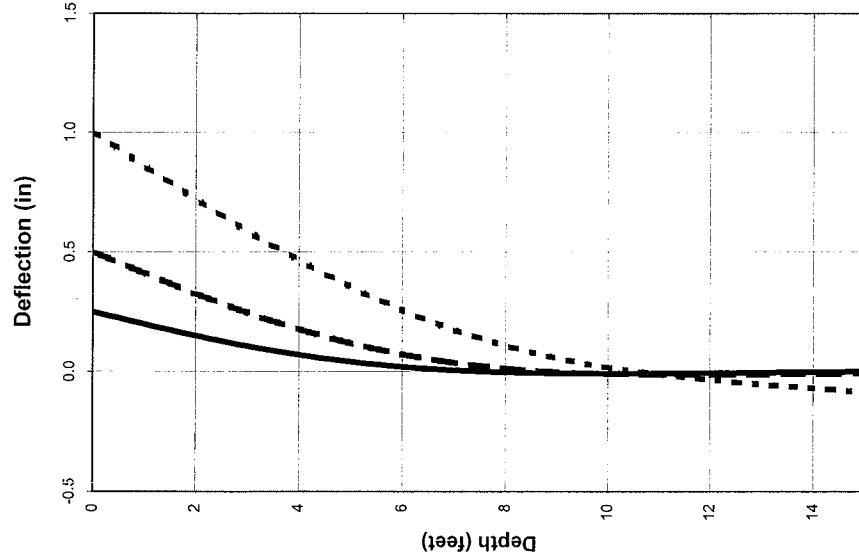
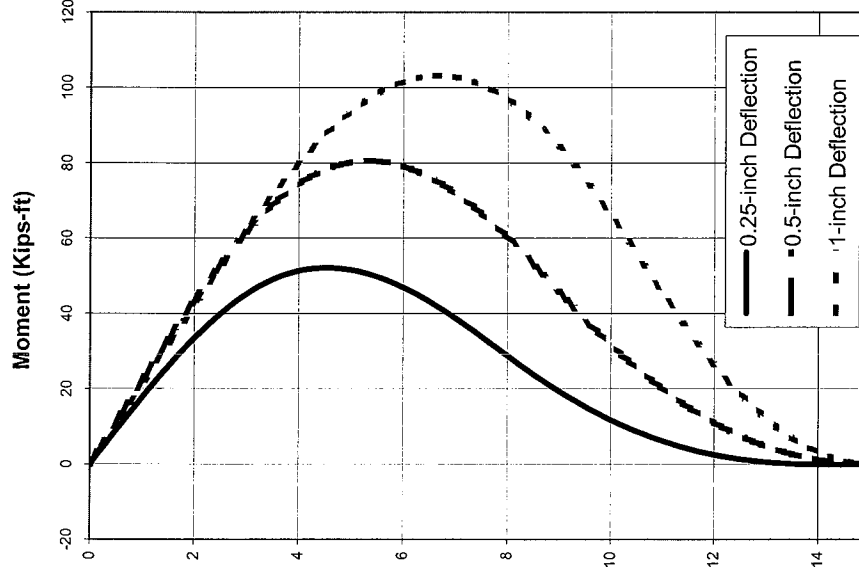
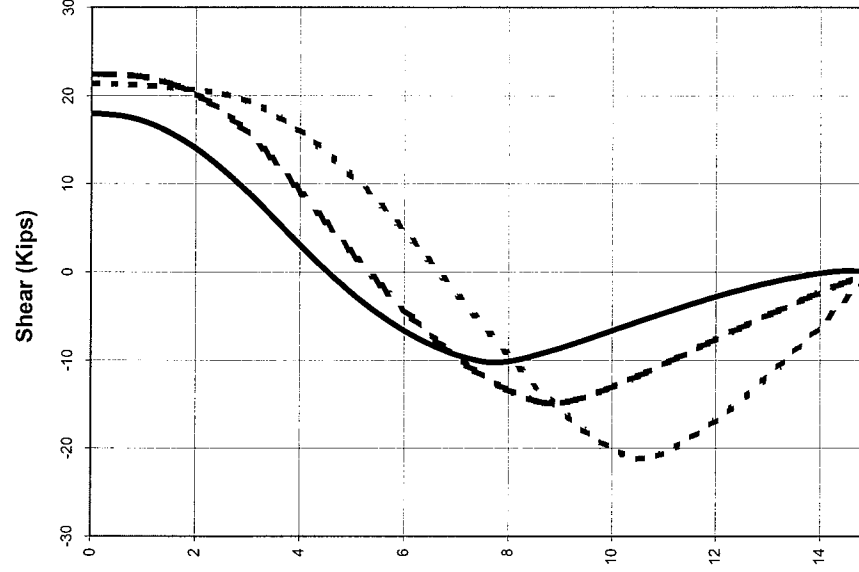
Figure 1b

SECTION A-A' (Boring B-1)

NOTE: Depth is depth of embedment below harbor bottom (k500pci)

LATERAL LOAD CAPACITIES: 14-INCH SQUARE CONCRETE PILE
 15-FOOT EMBEDMENT INTO BEDROCK
 PRELIMINARY SEAWALL EVALUATION
 DANA POINT HARBOR

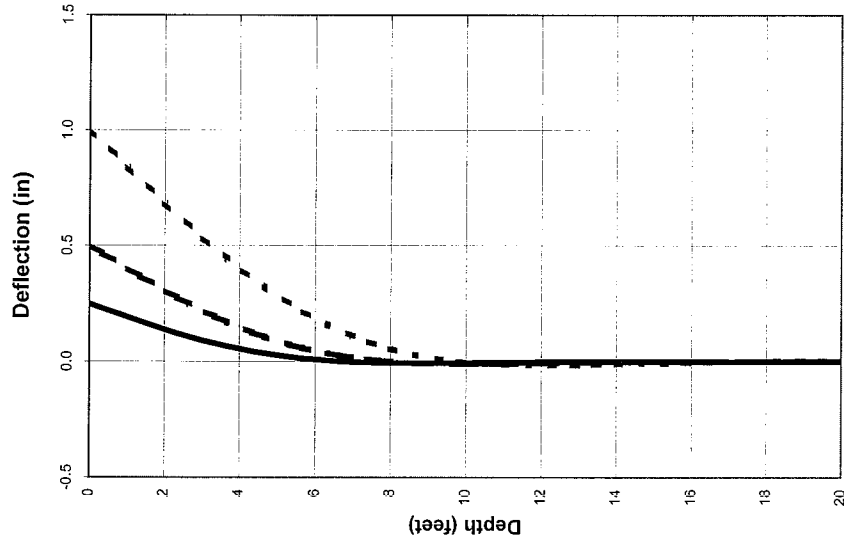
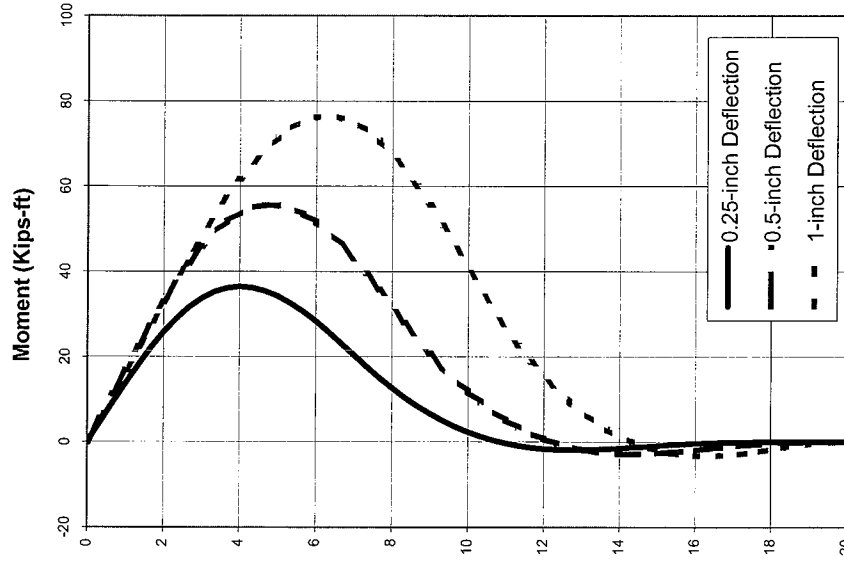
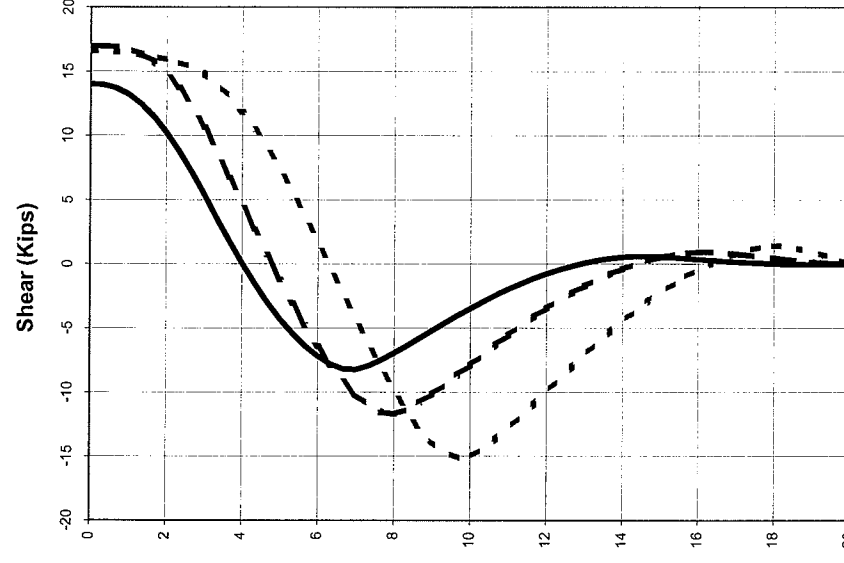
Figure 1c

SECTION A-A' (Boring B-1)

NOTE: Depth is depth of embedment below harbor bottom (k500pci)

LATERAL LOAD CAPACITIES: 14-INCH SQUARE CONCRETE PILE
 20-FOOT EMBEDMENT INTO BEDROCK
 PRELIMINARY SEAWALL EVALUATION
 DANA POINT HARBOR

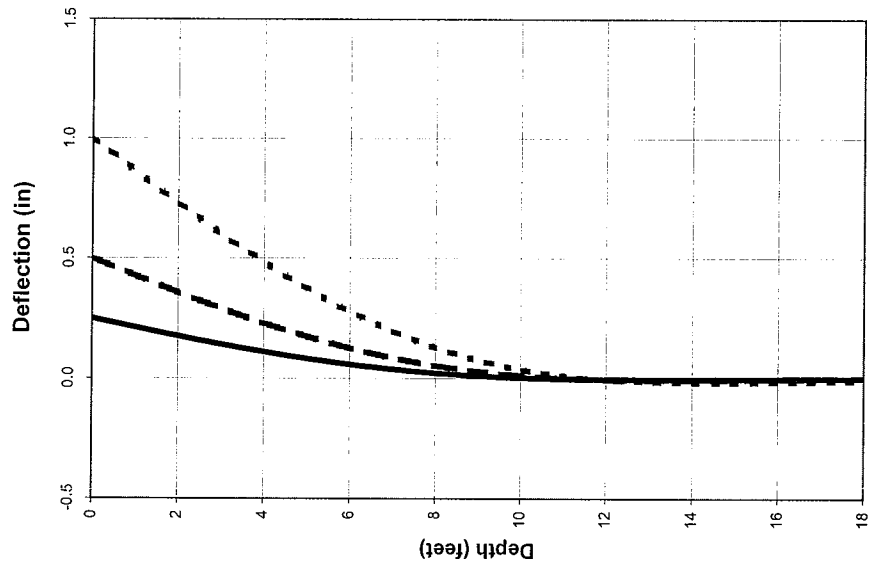
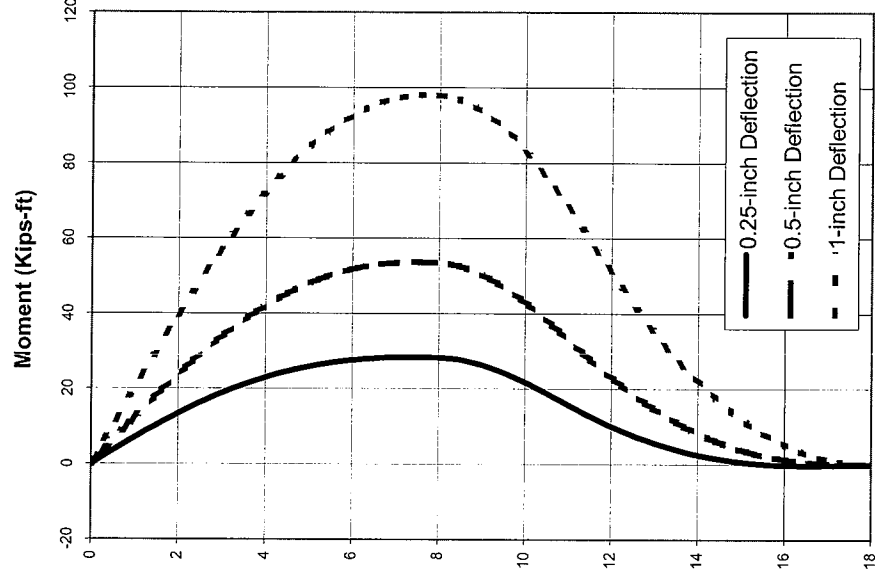
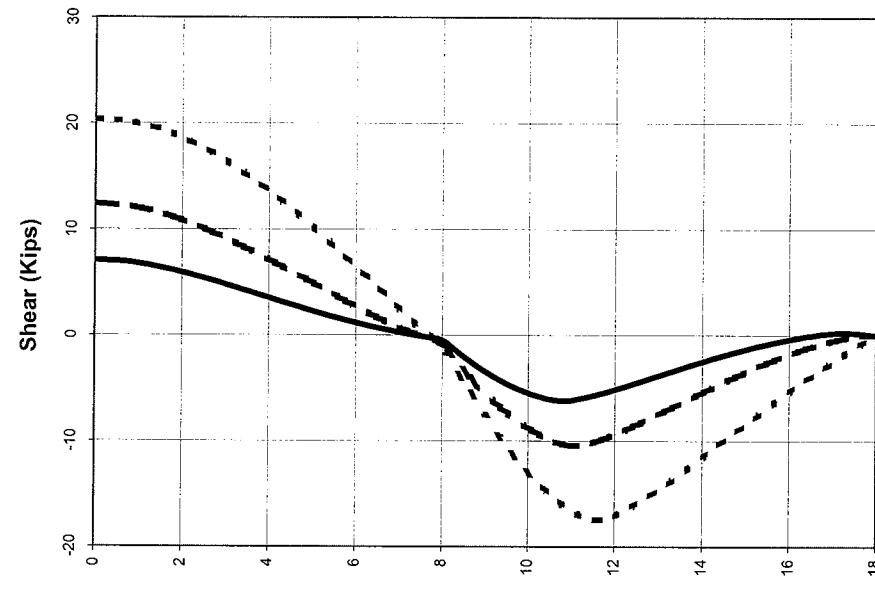
Figure 2b

SECTION B-B' (Boring B-3)

NOTE: Depth is depth of embedment below harbor bottom (k500pci)

LATERAL LOAD CAPACITIES: 14-INCH SQUARE CONCRETE PILE
 10-FOOT EMBEDMENT INTO BEDROCK
 PRELIMINARY SEAWALL EVALUATION
 DANA POINT HARBOR

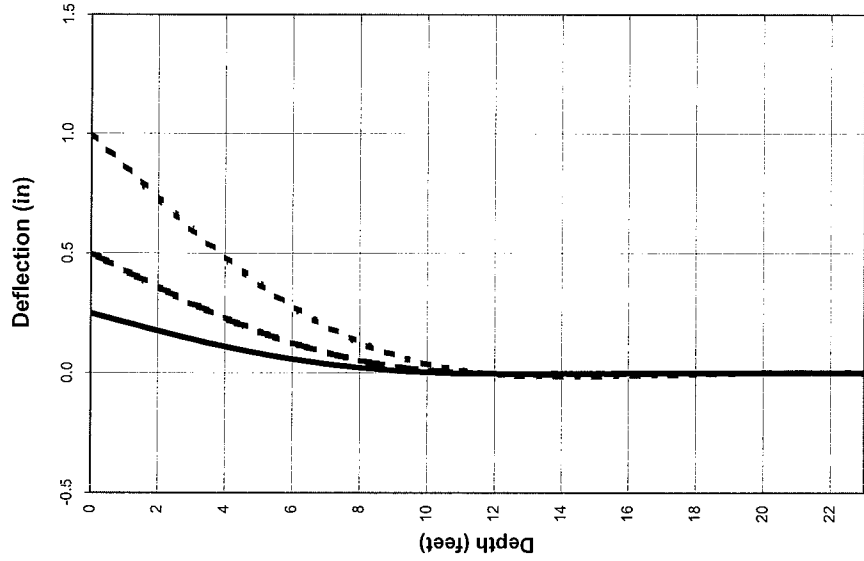
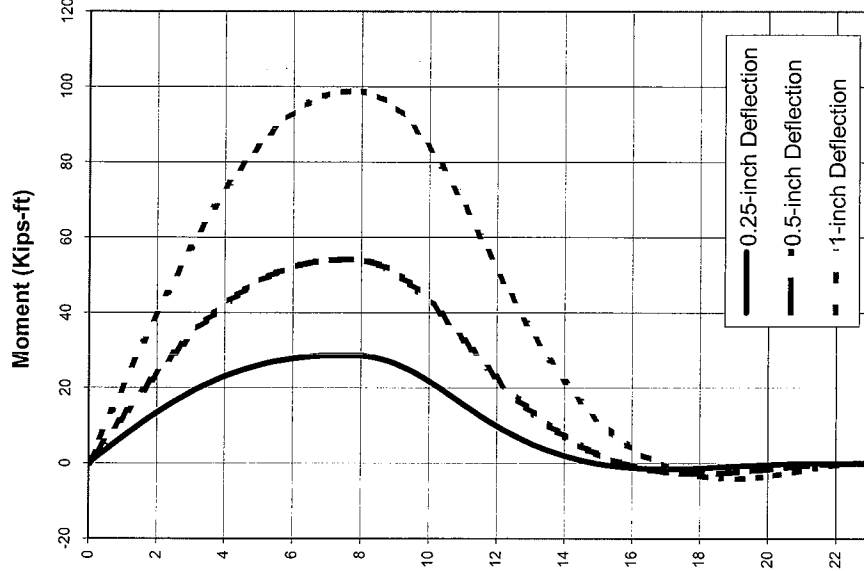
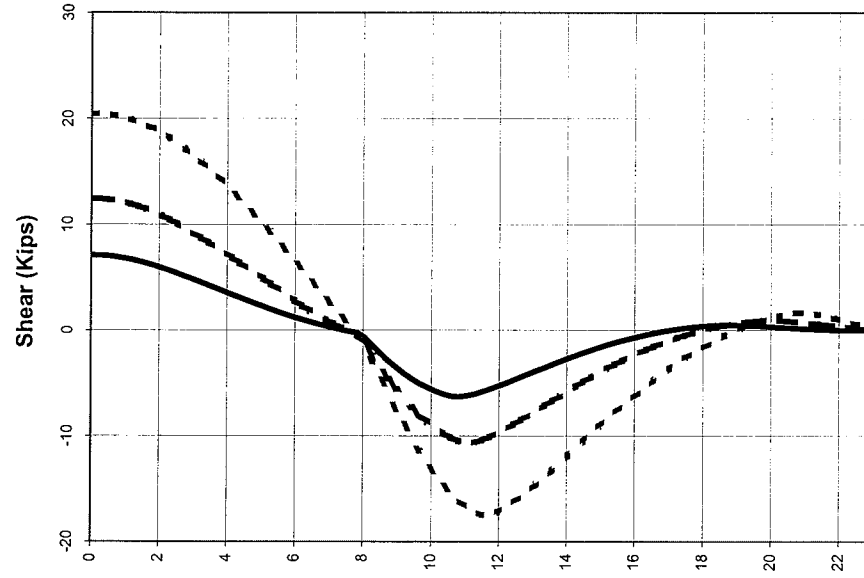
Figure 2c

SECTION B-B' (Boring B-3)

NOTE: Depth is depth of embedment below harbor bottom (k500pci)

LATERAL LOAD CAPACITIES: 14-INCH SQUARE CONCRETE PILE
 15-FOOT EMBEDMENT INTO BEDROCK
 PRELIMINARY SEAWALL EVALUATION
 DANA POINT HARBOR

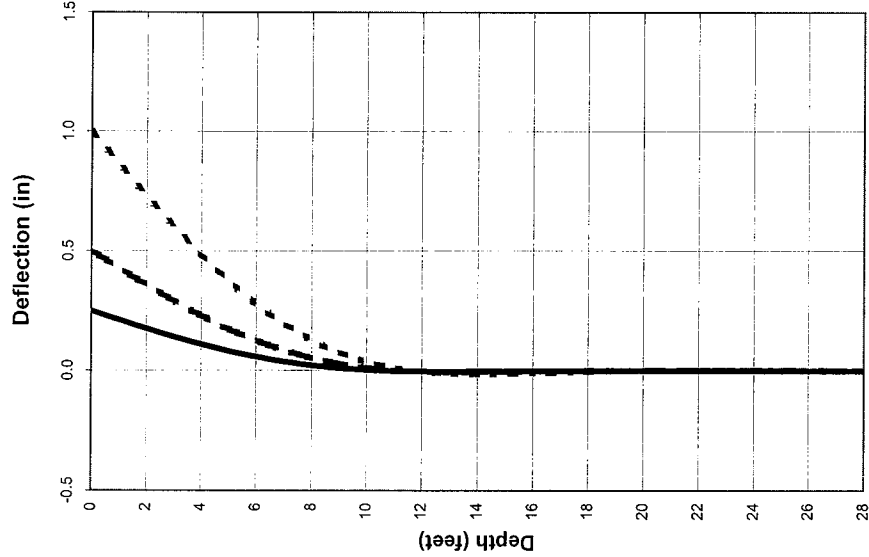
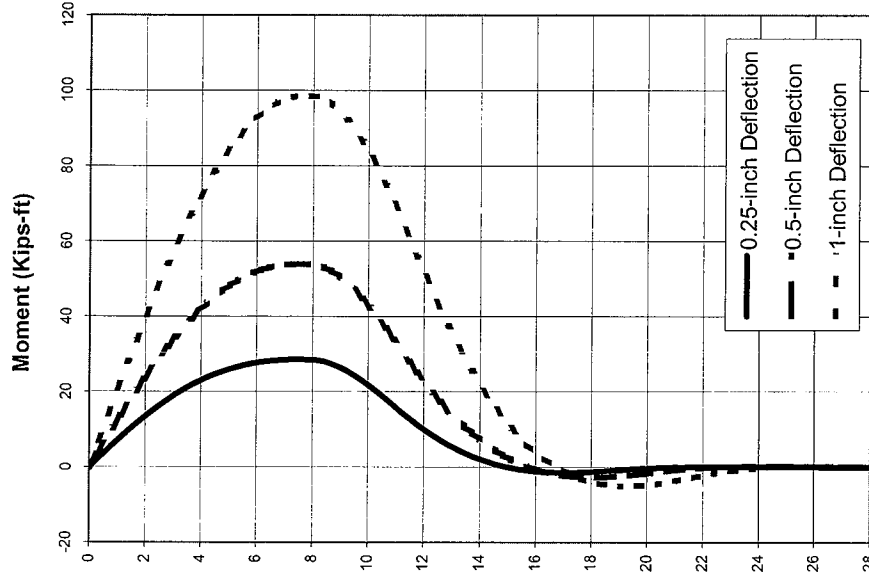
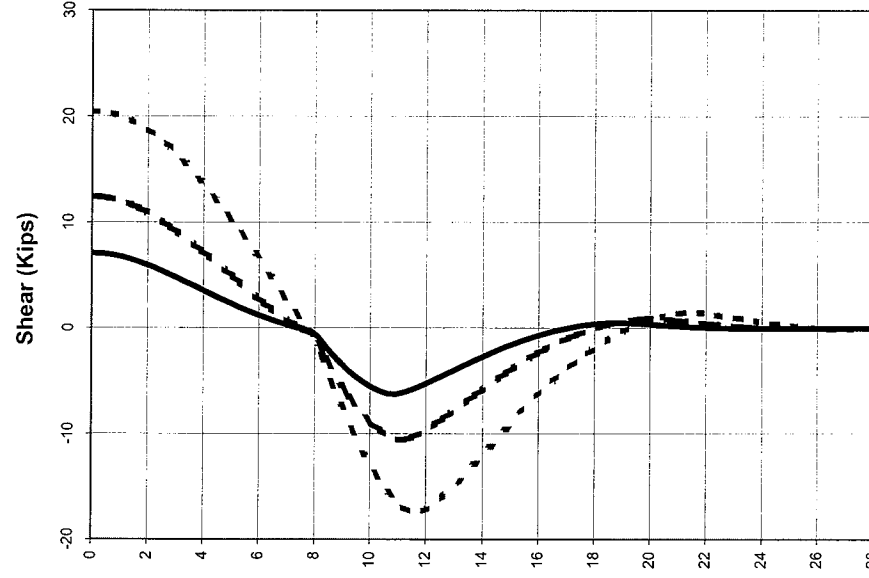
SECTION B-B' (Boring B-3)

NOTE: Depth is depth of embedment below harbor bottom (k500pci)

LATERAL LOAD CAPACITIES: 14-INCH SQUARE CONCRETE PILE
 20-FOOT EMBEDMENT INTO BEDROCK
 PRELIMINARY SEAWALL EVALUATION
 DANA POINT HARBOR

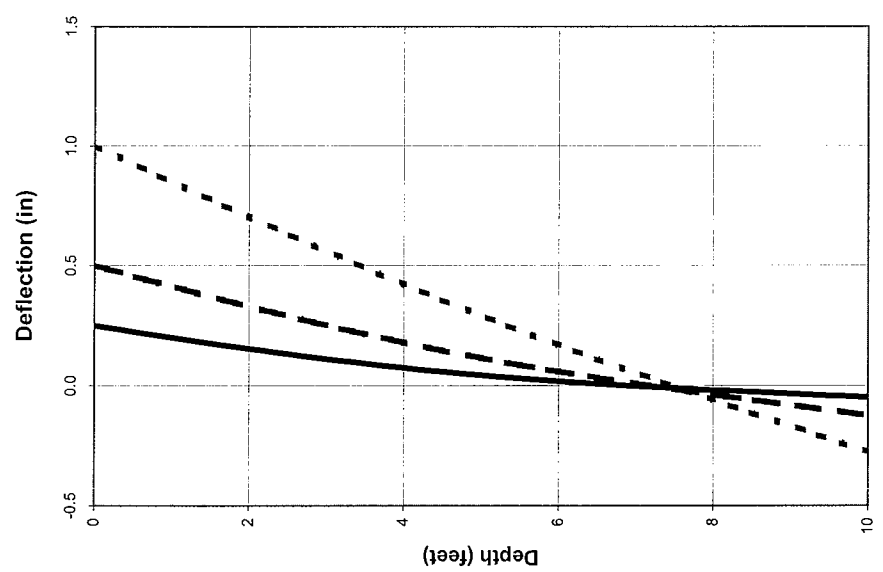
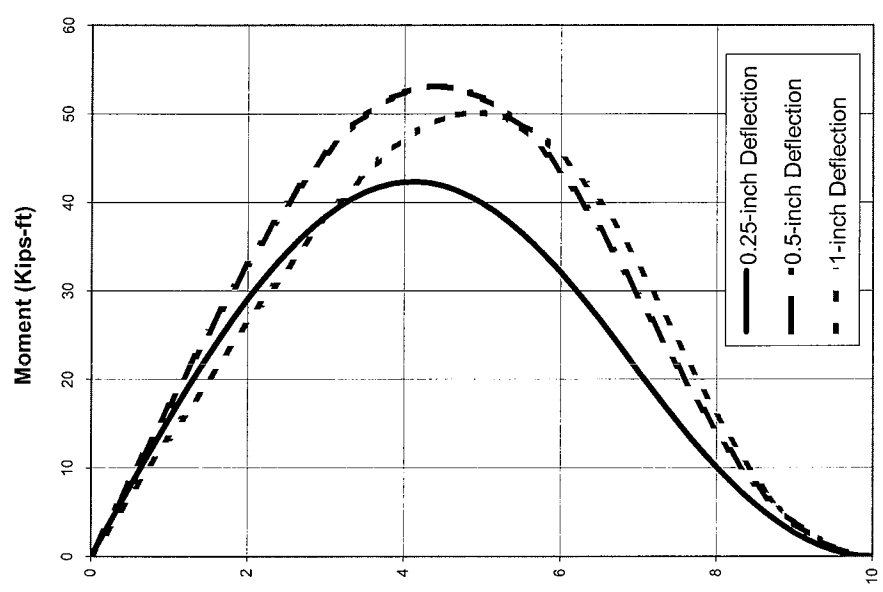
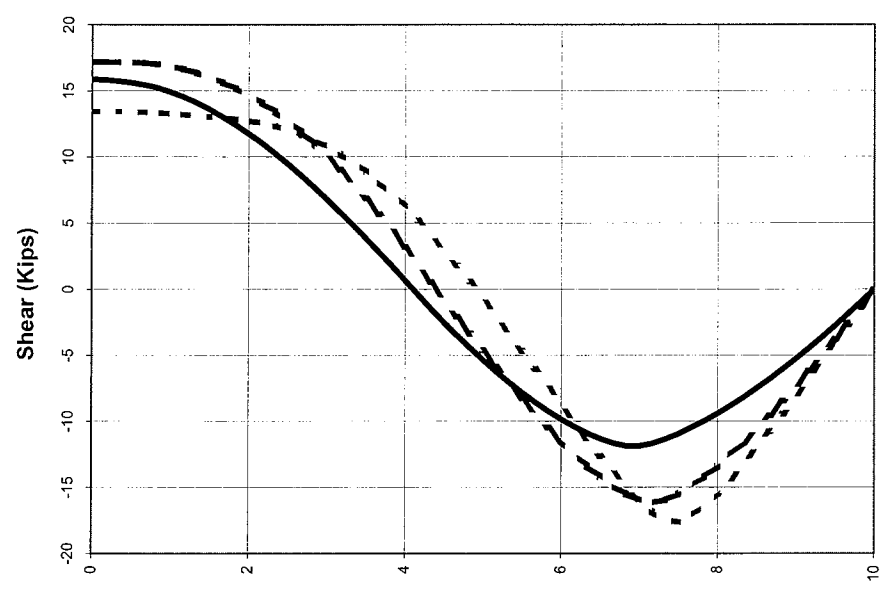
Figure 1a

SECTION A-A' (Boring B-1)

NOTE: Depth is depth of embedment below harbor bottom (k500pci)

LATERAL LOAD CAPACITIES: 16-INCH CIRCULAR CONCRETE PILE
 10-FOOT EMBEDMENT INTO BEDROCK
 PRELIMINARY SEAWALL EVALUATION
 DANA POINT HARBOR

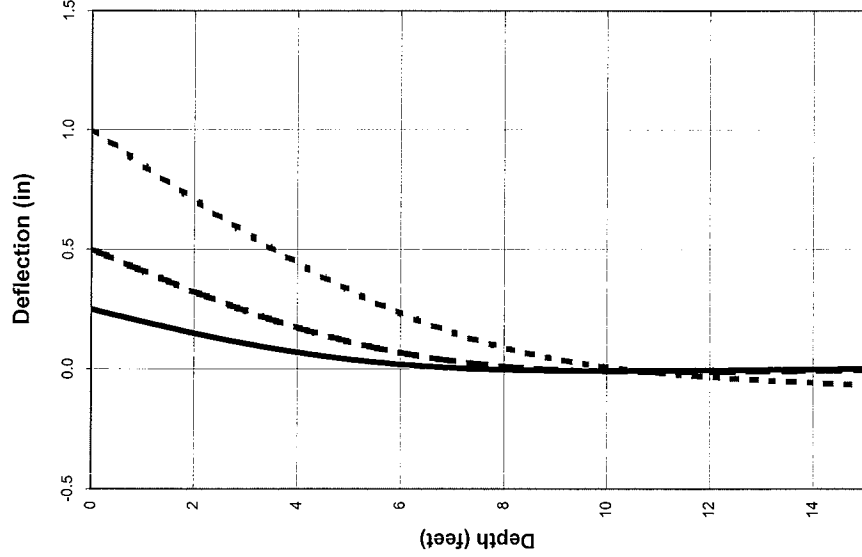
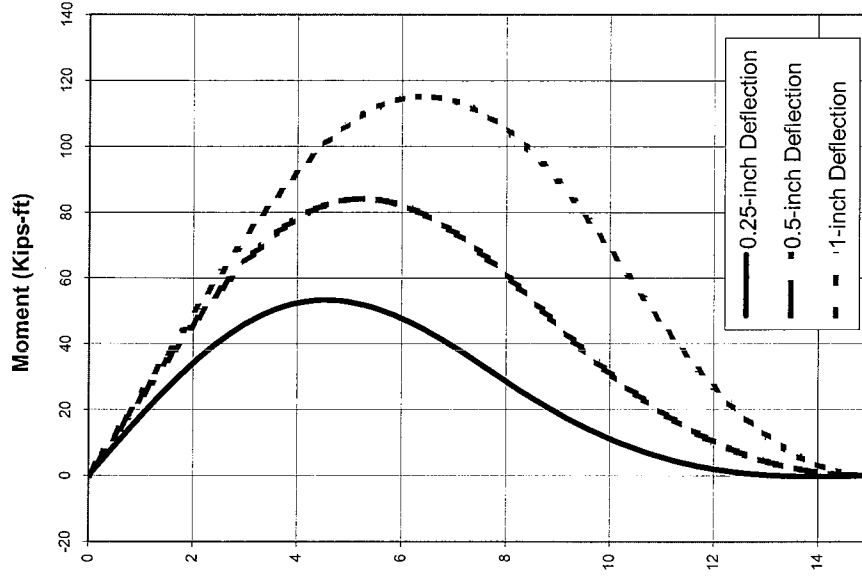
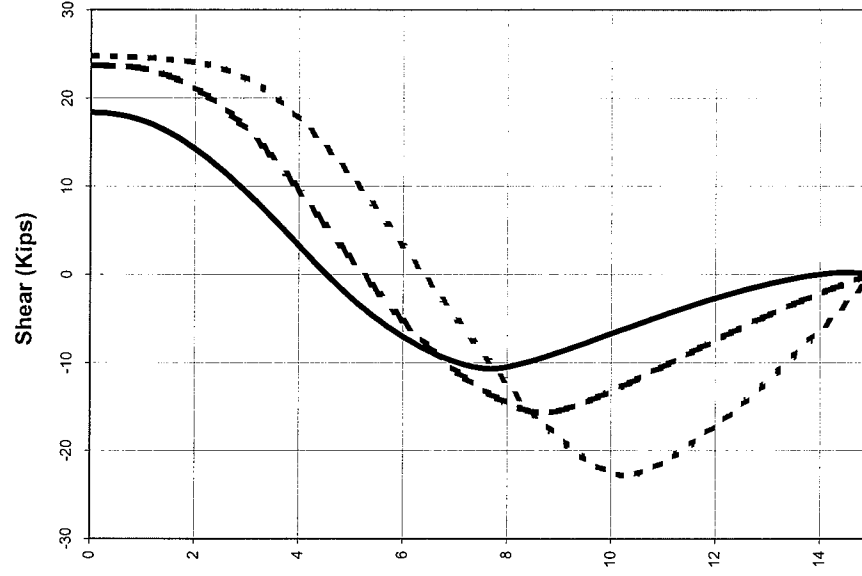
Figure 1b

SECTION A-A' (Boring B-1)

NOTE: Depth is depth of embedment below harbor bottom (k500pci)

LATERAL LOAD CAPACITIES: 16-INCH CIRCULAR CONCRETE PILE
 15-FOOT EMBEDMENT INTO BEDROCK
 PRELIMINARY SEAWALL EVALUATION
 DANA POINT HARBOR

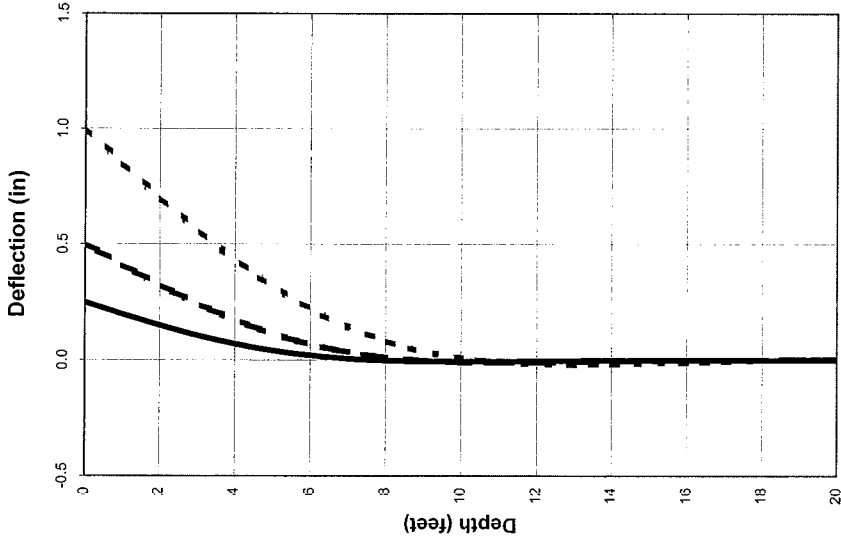
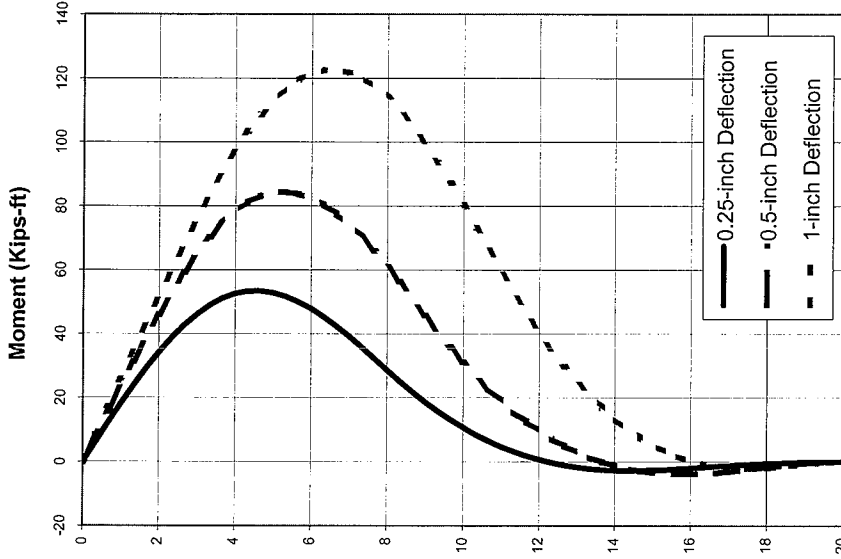
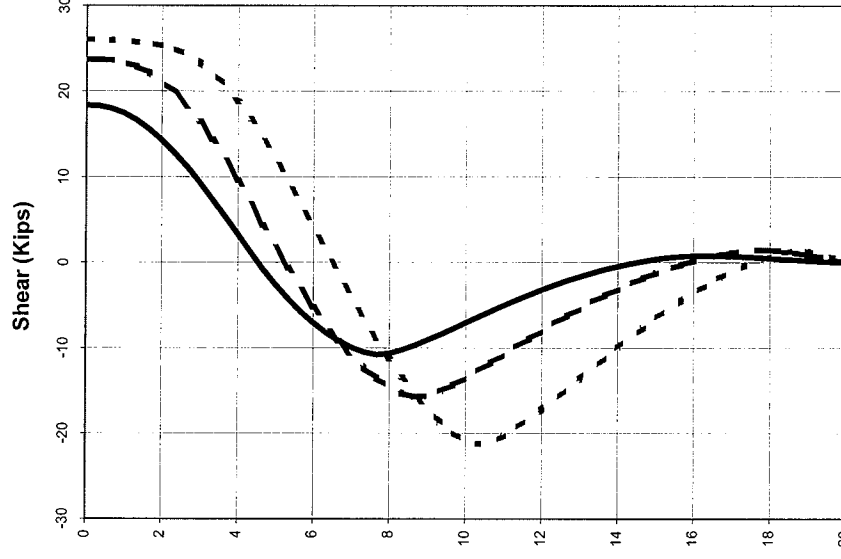
Figure 1c

SECTION A-A' (Boring B-1)

NOTE: Depth is depth of embedment below harbor bottom (k500pci)

LATERAL LOAD CAPACITIES: 16-INCH CIRCULAR CONCRETE PILE
 20-FOOT EMBEDMENT INTO BEDROCK
 PRELIMINARY SEAWALL EVALUATION
 DANA POINT HARBOR

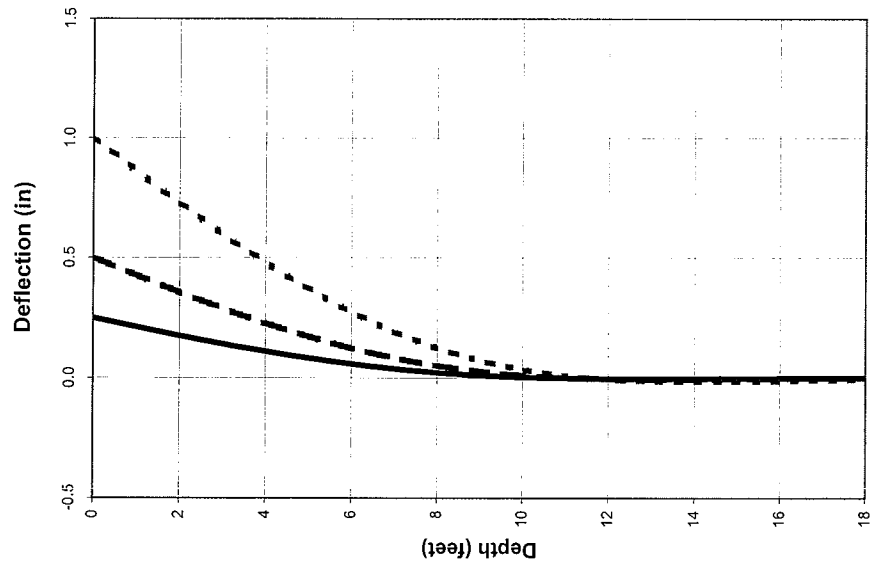
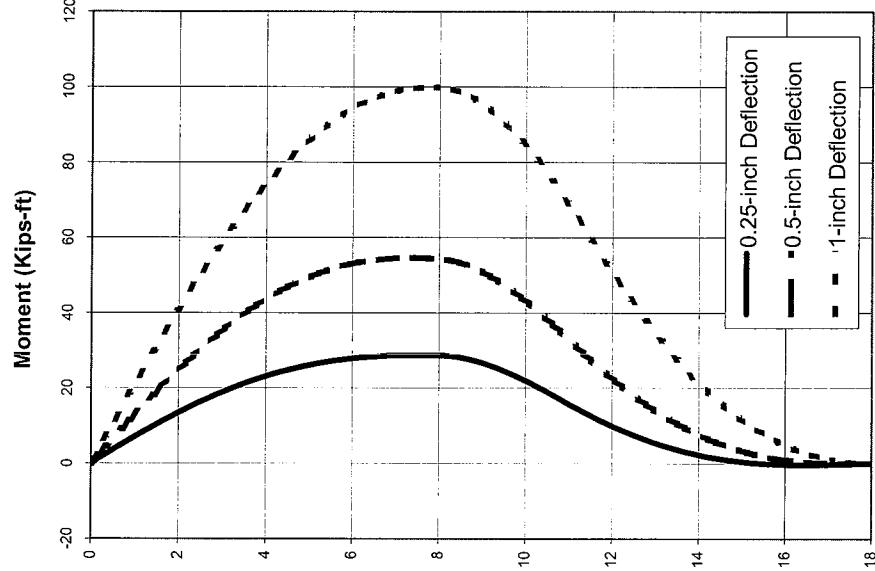
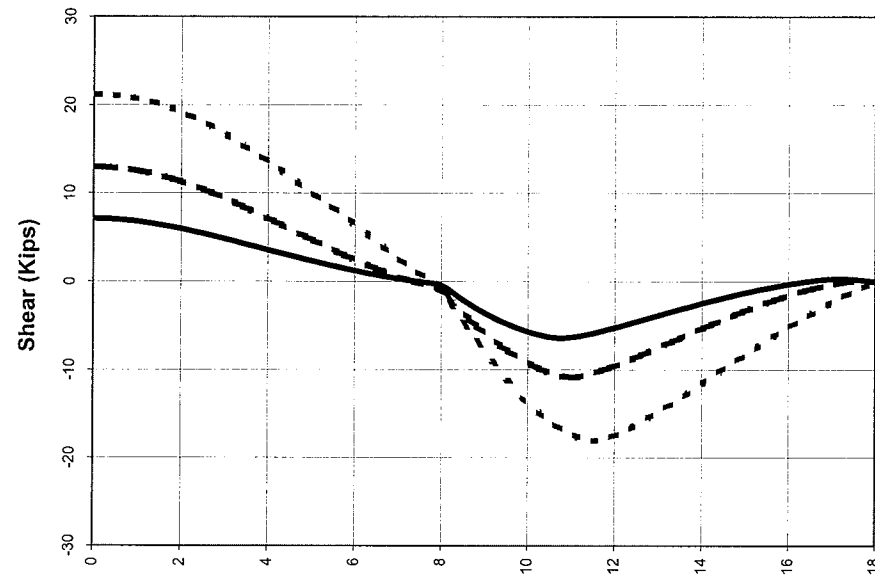
Figure 2b

SECTION B-B' (Boring B-3)

NOTE: Depth is depth of embedment below harbor bottom (k500pci)

LATERAL LOAD CAPACITIES: 16-INCH CIRCULAR CONCRETE PILE
 10-FOOT EMBEDMENT INTO BEDROCK
 PRELIMINARY SEAWALL EVALUATION
 DANA POINT HARBOR

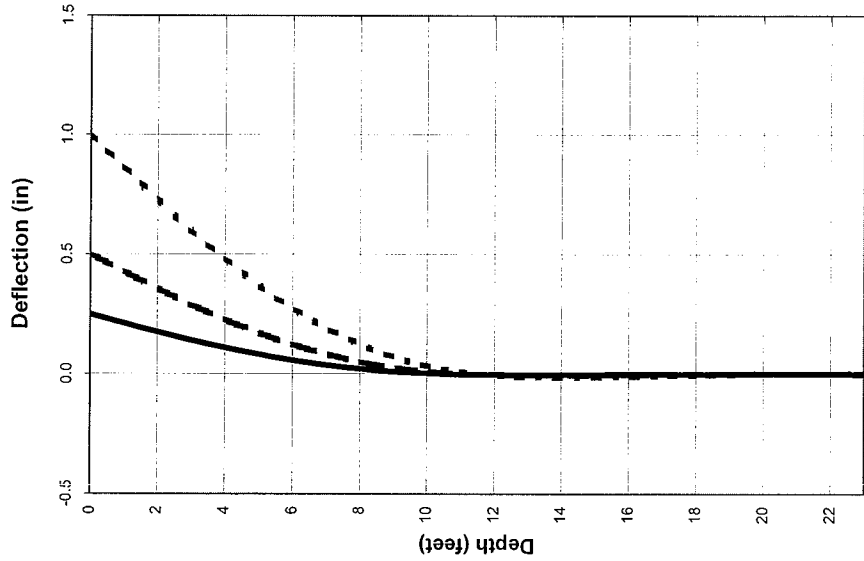
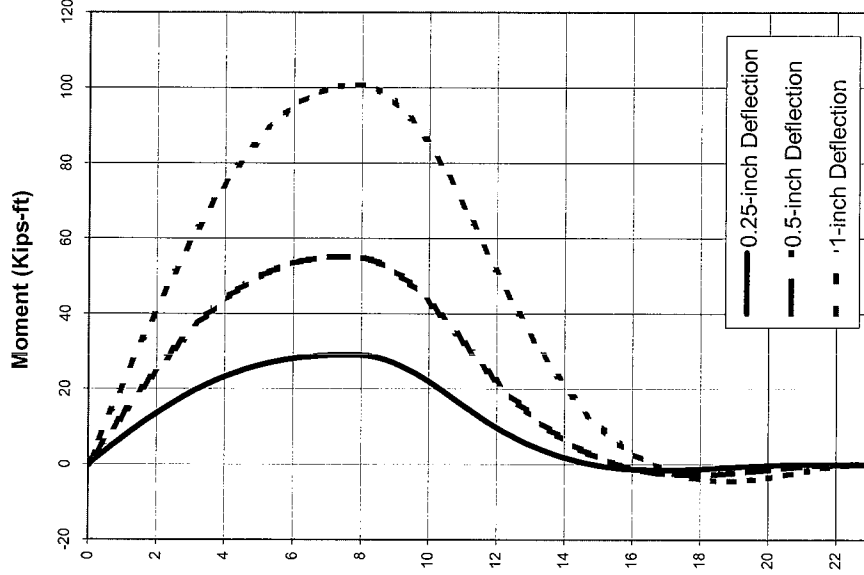
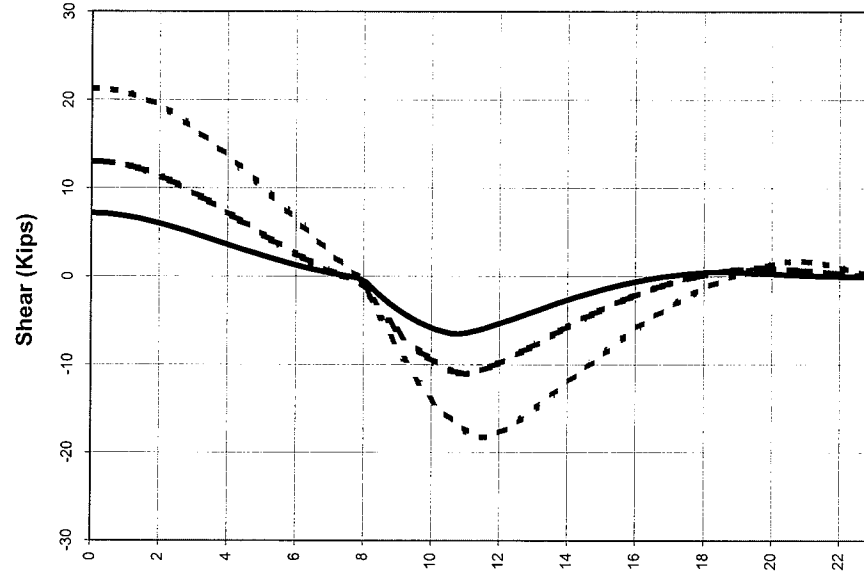
Figure 2c

SECTION B-B' (Boring B-3)

NOTE: Depth is depth of embedment below harbor bottom (k500pci)

LATERAL LOAD CAPACITIES: 16-INCH CIRCULAR CONCRETE PILE
 15-FOOT EMBEDMENT INTO BEDROCK
 PRELIMINARY SEAWALL EVALUATION
 DANA POINT HARBOR

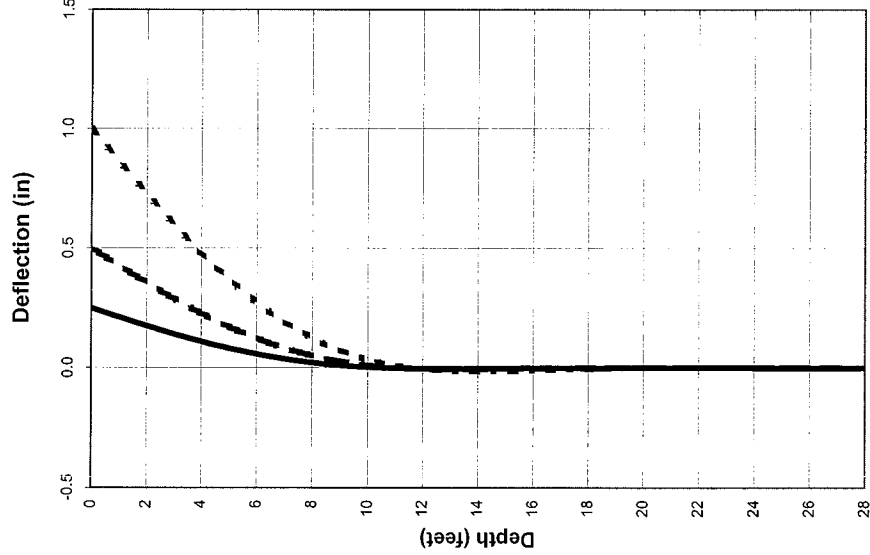
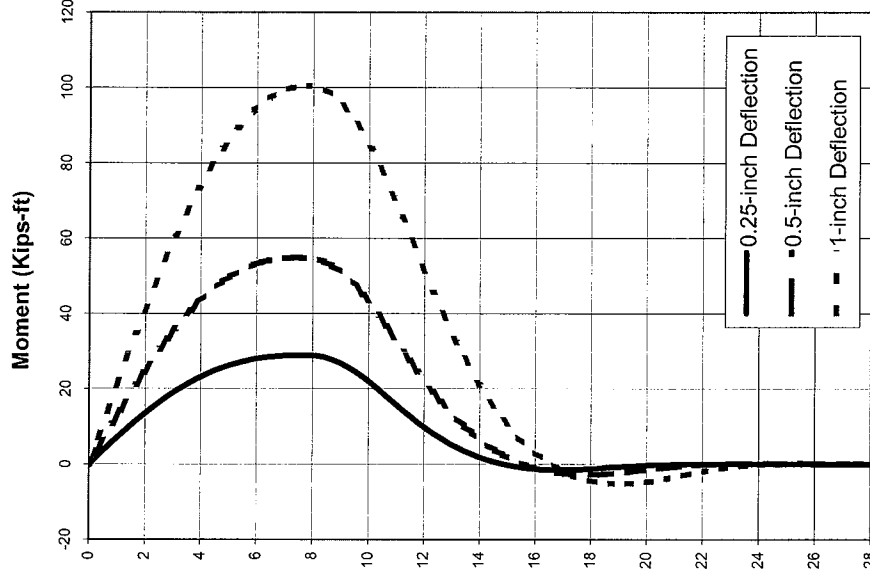
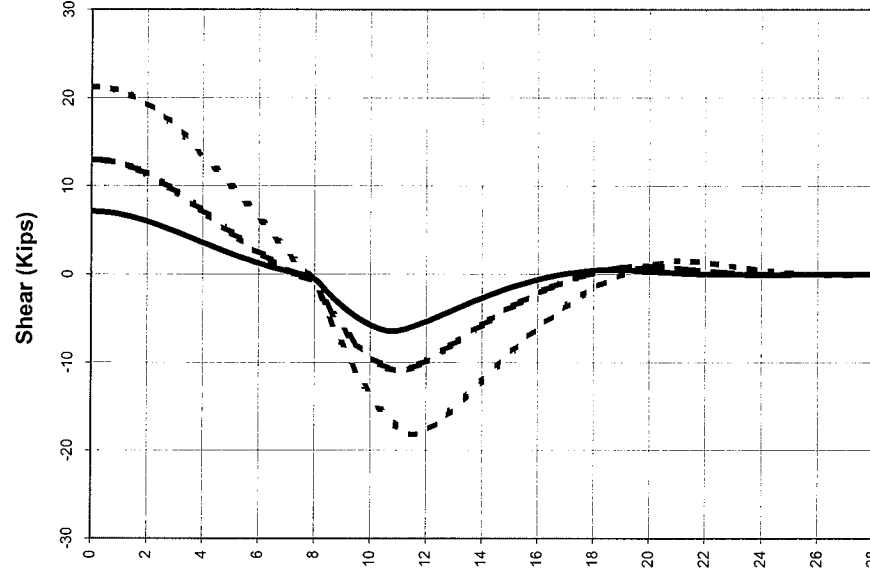
SECTION B-B' (Boring B-3)

NOTE: Depth is depth of embedment below harbor bottom (k500pci)

LATERAL LOAD CAPACITIES: 16-INCH CIRCULAR CONCRETE PILE
 20-FOOT EMBEDMENT INTO BEDROCK
 PRELIMINARY SEAWALL EVALUATION
 DANA POINT HARBOR
