**MARINE BIOLOGICAL RESOURCES: FOCUSED SURVEY REPORT
FOR EELGRASS (*ZOSTERA MARINA*) AND
INVASIVE ALGAE (*CAULERPA TAXIFOLIA* AND *UNDARIA PINNATIFIDA*)
FEBRUARY-MARCH 2007 SURVEYS
DANA POINT HARBOR MARINA RENOVATION PROJECT
DANA POINT, CALIFORNIA**

**Prepared for:
LSA Associates, Inc.
20 Executive Park, Suite 200, Irvine, California
Contact: Rob Balen
(949) 533-0666**

**Prepared by:
Coastal Resources Management, Inc.
PMB 327, 3334 E. Coast Highway, Corona del Mar, CA 92625
Contact: Rick Ware, Senior Marine Biologist
(949) 412-9446**

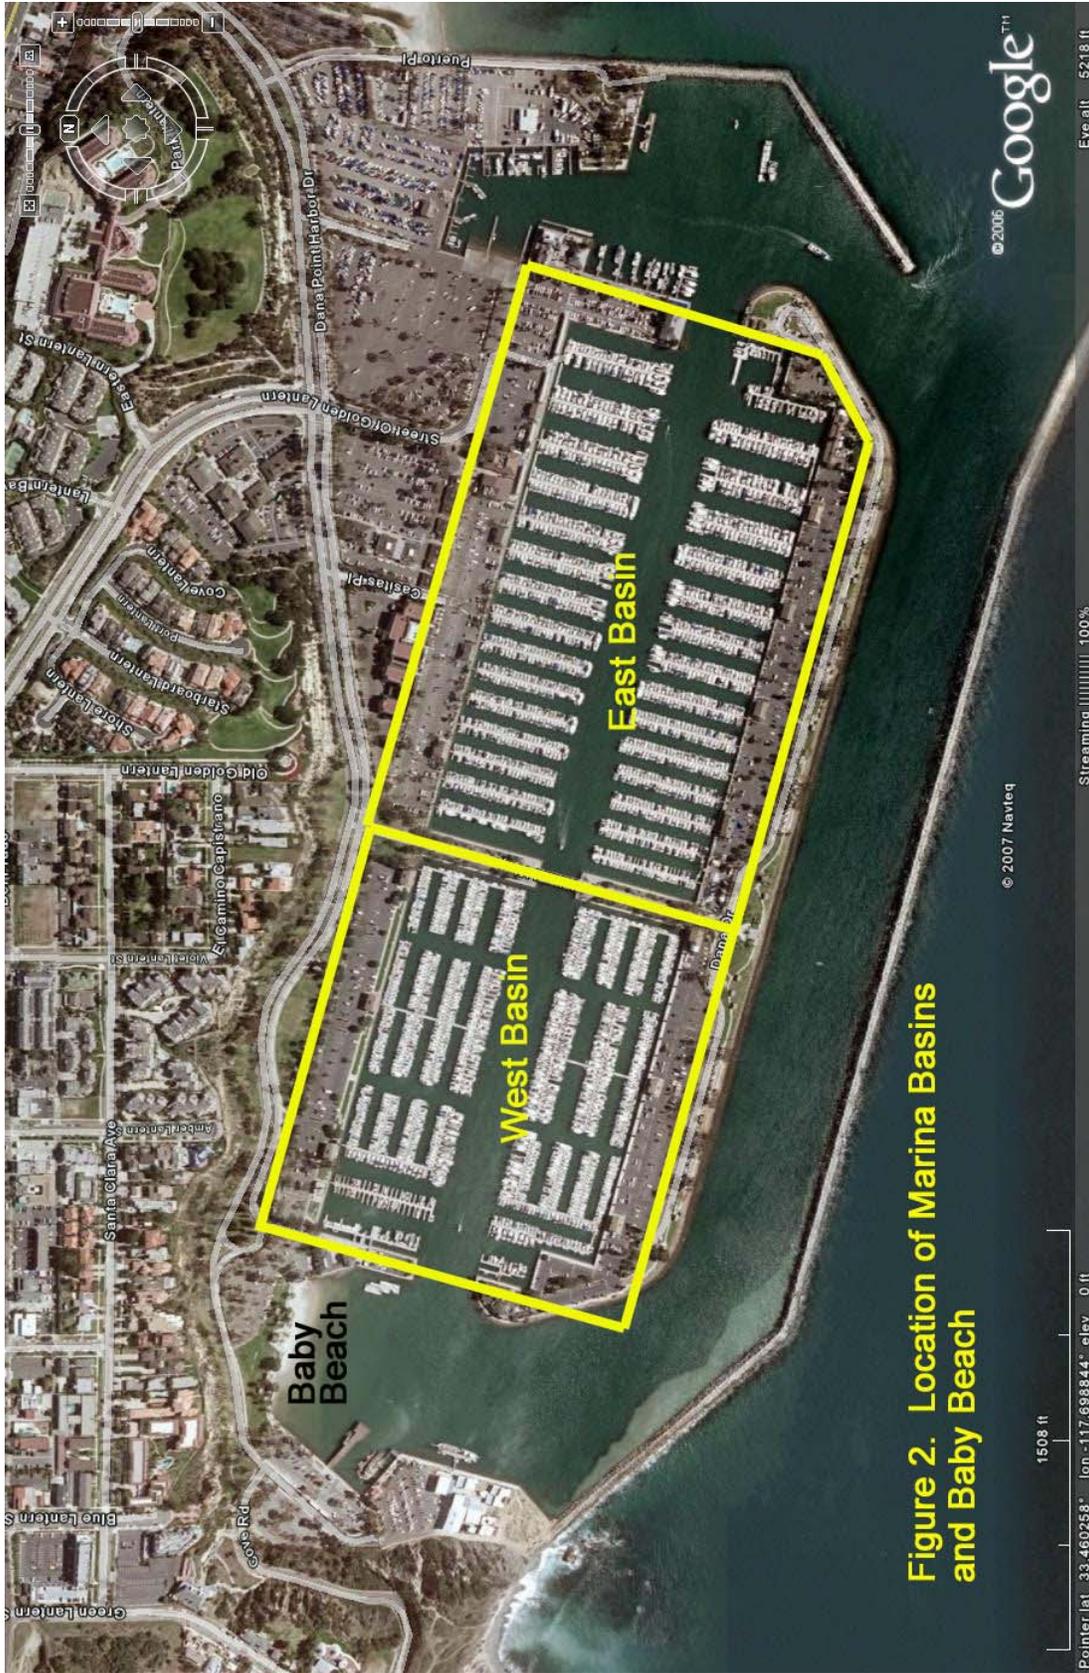
Figure 2. Location of Marina Basins and Baby Beach

The marina within Dana Point Harbor is divided into two basins, the East Basin and West Basin (Figure 2). Each basin operates as a separate marina, with a total capacity of about 2,500 shallow-draft vessels. The boat launch ramp at the northeast corner of the harbor is newly upgraded as of July 2007. Other facilities within the harbor include the Dana Point Marine Institute, a dry boat storage hoist, fishing pier, shipyard, marine fuel dock, three yacht clubs, and a commercial sports fishing operation. Swimming is allowed at the west end of the Harbor, at Baby Beach. (<http://www.ocparks.com/danapointharbor/>)

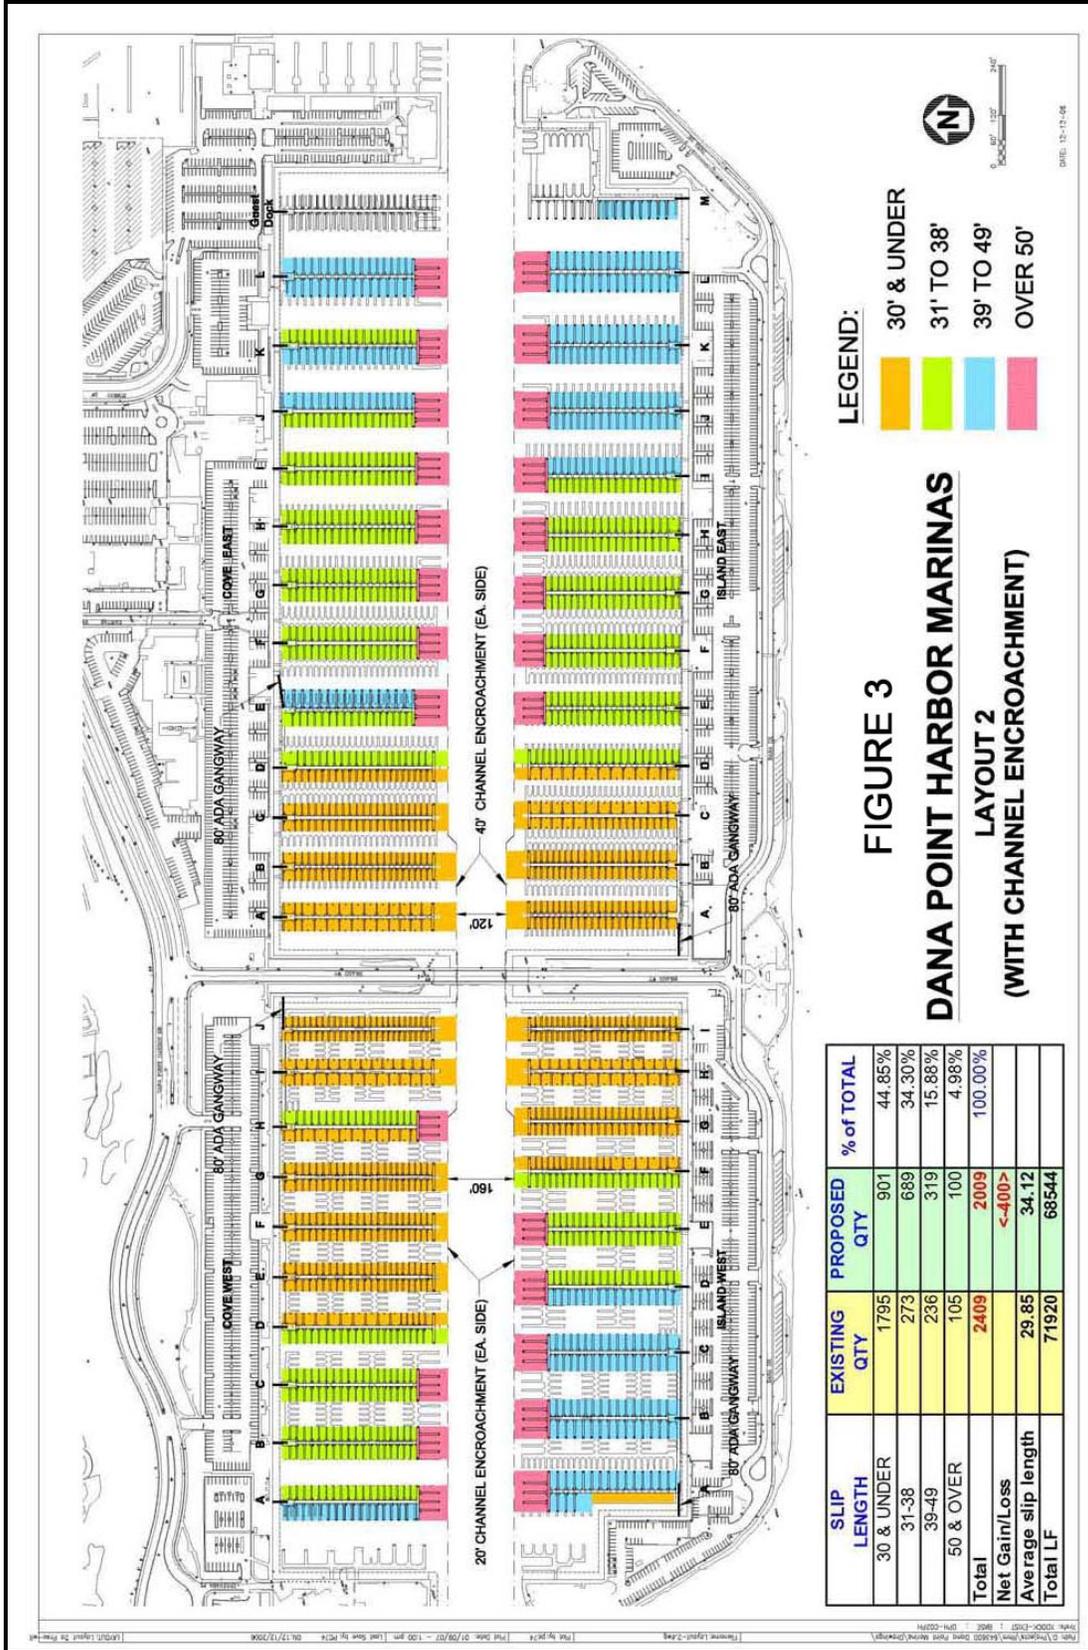
The County of Orange proposes upgrade landside and waterside facilities within Dana Point Harbor. Waterside-upgrades include the renovation of the marina basin dock systems by replacing old and deteriorating docks, slips and gangways with new facilities (Figure 3). The number of boat slips will decrease to 2,009 (Marina Layout 2 with channel encroachment). A total of 1,163 existing piles will be removed and approximately 933 new piles will be emplaced. In addition, the proposed project includes adding handicap access at locations that is currently not available; Bulkheads will not be affected by the project. This report only addresses the waterside upgrade of the marina dock systems

The proposed Dana Point Marina dock layout is shown in Figure 3. New floating docks systems will consist of prefabricated, lightweight aggregate concrete modules. No creosote treated wood products will be included in the new concrete dock system. Marina improvements would be made over eight phases, in which between 250-350 vessels per phase would be moved to temporary docks. Within each area, the phases will include the removal of the existing dock and piles, and the installation of the new dock and piles. Piles will be removed by vibratory extraction equipment mounted to a crane operating from a barge. However, if piles break off at the mudline, they will be manually cut two to three feet below the mudline. The old piles and floating docks will be lifted from the water using a crane and then trucked off-site.

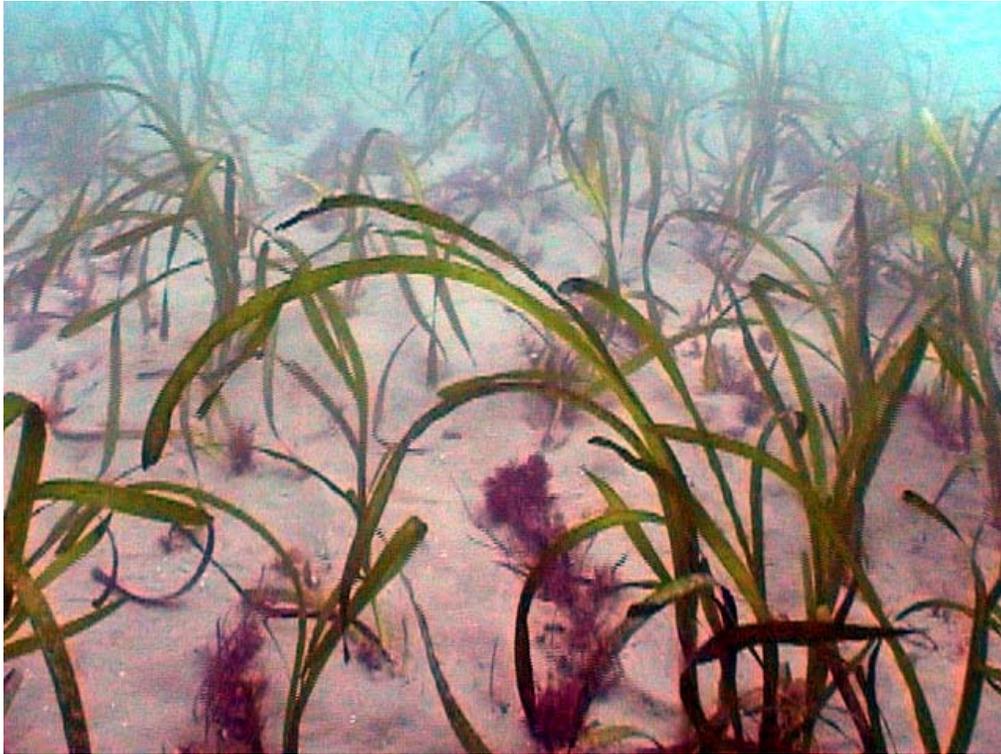
Eelgrass (Figure 5) is a marine flowering plant that grows in soft sediments in coastal bays and estuaries, and occasionally offshore to depths of 50 feet (ft). Eelgrass canopy (consisting of shoots and leaves added vegetation and the vertical relief it provides enhances the abundance and the

Figure 5. Eelgrass, *Zostera marina*. One “shoot” and the cluster of “blades” arising from the shoot is considered a “turion unit”.

No eelgrass was observed during the underwater biological investigations within the marina basins of Dana Point Harbor or at Baby Beach. In a previous survey, Chambers Group, Inc (2005) found a single, three-turion plant at the eastern end of Baby Beach in April 2005.

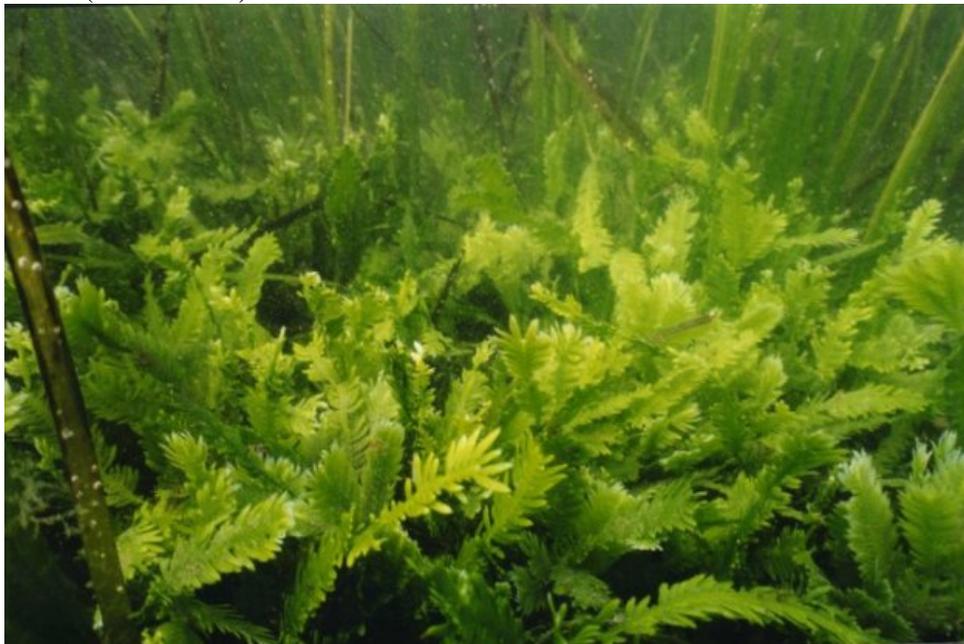
Invasive algae (Figure 6) has a potential to cause ecosystem-level impacts on California's bays and nearshore systems due to its extreme ability to out-compete other algae and seagrasses. *Caulerpa taxifolia* grows as a dense smothering blanket, covering and killing all native aquatic vegetation in its path when introduced in a non-native marine habitat. Fish, invertebrates, marine mammals, and sea birds that are dependent on native marine vegetation are displaced or die off from the areas where they once thrived. It is a tropical-subtropical species that is used in aquariums. It was introduced into southern California in 2000 (Agua Hedionda Lagoon) and (Huntington Harbour) by way of individuals likely dumping their aquaria waters into storm drains, or directly into the lagoons. While outbreaks have been contained, the Water Resources Board, through the National Marine Fisheries Service and the California Department of Fish and Game require that projects that have potential to spread this species through dredging, and bottom-disturbing activities conduct pre-construction surveys to determine if this species is present using standard agency-approved protocols and by National Marine Fisheries Service/California Department of Fish and Game Certified Field Surveyors.

Figure 6. The invasive algae, *Caulerpa taxifolia*. Source: NOAA/NMFS

No *Caulerpa* was found within the Dana Point marina basins or in the vicinity of Baby Beach. It has not been reported to have been present in Dana Point Harbor in previous surveys (Chambers Group, Inc. 2005, 2006). As noted in Section 3.1, the combined *Caulerpa*-eelgrass dive surveys covered a total of 12,228 sq m (3 acres) of bayfloor habitat within the east and west marina basins and a total of 6,650 sq m (1.64 acres) in the vicinity of Baby Beach and the Youth Sailing Center. Overall, the bottom area of cover surveyed by biologist was 14% in the marina basins and between 58% and 65% at Baby Beach and the Youth Sailing Center. The higher intensity surveys were conducted at Baby Beach and the Youth Sailing Center because the area had a greater probability of locating either eelgrass or *Caulerpa*, since a very small patch of eelgrass (three turions) was located there in April 2005 by Chambers Group, Inc. (Chambers Group, Inc. 2005). The invasive algae reporting form, submitted to the National Marine Fisheries Service and the California Department of Fish and Game is provided in Appendix A. Prior to marina construction, a pre-construction *Caulerpa* survey will need to be conducted that attains a minimum survey intensity level of 20% to meet the standard of the Southern California *Caulerpa* Action Team (NMFS 2006).

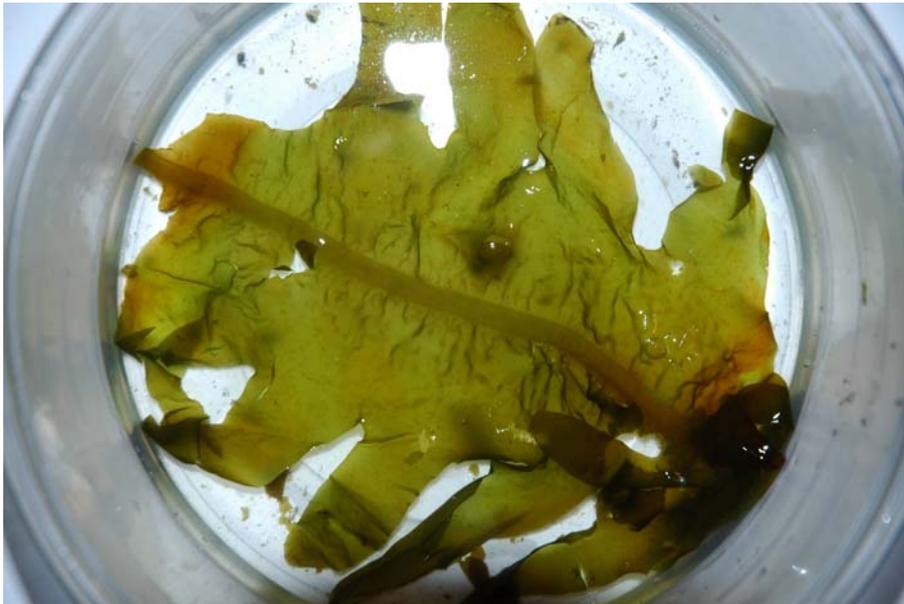
Figure 7. *Undaria pinnatifida*

Undaria pinnatifida (Figure 7) is a golden brown kelp native to the Japan Sea. It has been introduced in Australia, New Zealand, and Europe and has now spread to the California coastline. It has been found in Santa Barbara Harbor, Long Beach Harbor, Anaheim Bay, San Diego Bay, and on Catalina Island. *Undaria* was not observed during dive surveys in Dana Point Harbor in February or March, 2007.

In Japan it is known as wakame and is extensively cultivated as a fresh and dried food plant. However, it has the potential to become a major pest in our coastal waters. *Undaria* grows to between 3 to 7 feet (1 and 2 m) tall and is found in sheltered harbor waters on rocks, breakwaters, and marine debris from the low-tide mark to 50 feet (15 m). A mature plant has a distinctive, spiraled (frilly), spore-producing structure at its base. It also has an obvious central stem to 4 inches (10 cm) wide that extends for the length of the plant (Figure 7). The blade may be up to 3.1 feet (1 m) wide and extends from the tip of the plant for half the length of the plant.
